### MARYLAND HISTORICAL TRUST DETERMINATION OF ELIGIBILITY FORM

WO-568

### Trinity United Methodist Church

# Maryland Historical Trust Maryland Inventory of Historic Properties Form

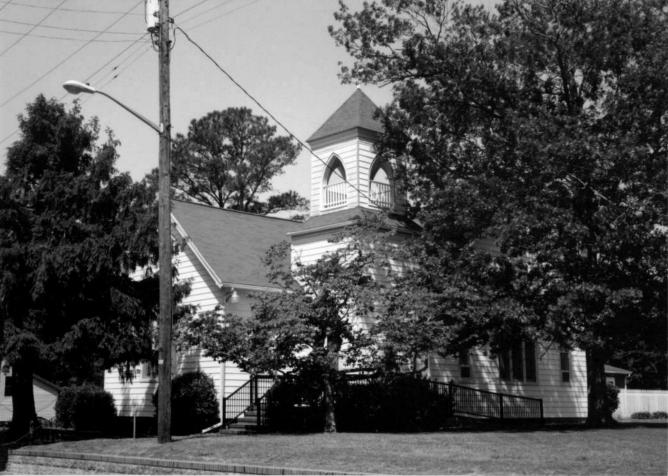
Inventory No. WO-568
Trinity United Methodist Church
Worcester County. Maryland
Heather Menney
May 29, 2007
MO SHPO
Southeast corner of building looking northwest.
#1 of 2

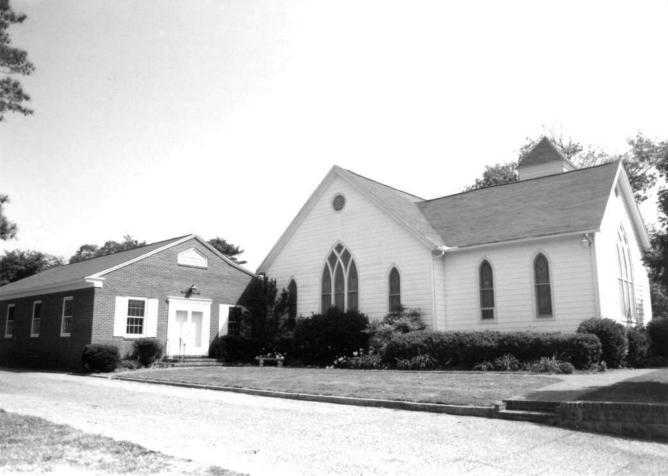
Inventory No. 568
Trinity United Methodist Church
Worcester County, Maryland
Heather Kenney
May 29, 2007
MD SHPO
Southwest Corner of building looking northeast.
#2 of 2
